Report of Findings

Jetson Fire Origin & Cause Claim Number: 5015617702

Rimkus Matter No: 100162188

September 12, 2024 EXHIBIT A

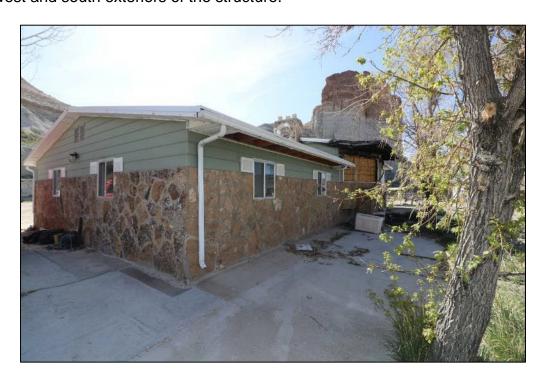
The west and south exteriors of the structure.

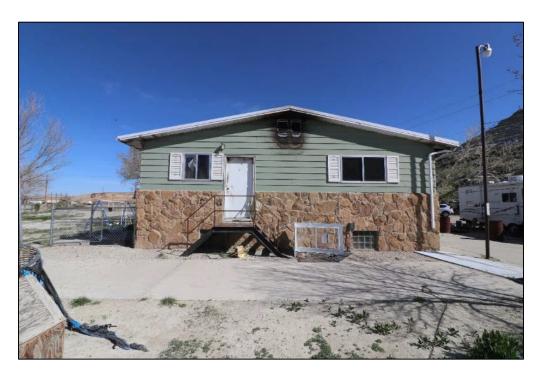
The east exterior of the structure.

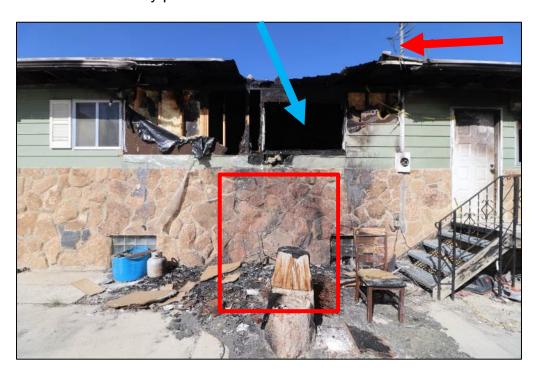
The most severe fire damage along the north exterior wall occurred around and below the Bedroom #4 window. Ventilation patterns were present around the window. Mass loss of the wood framing, sheathing, and roofing materials occurred around the roof eaves. The mass loss of these materials was most severe at the east side of the Bedroom #4 window. The eave framing was mostly consumed by the fire at the east side of the window. Mass loss of the aluminum window frame occurred at the bottom left (east) side of the window frame, and the top portion of the window frame. Mass loss of wood framing at the window opening was most severe at the left (east) side of the window frame.

Oxidation patterns around and below the window occurred on the surface of the metal siding. The metal siding was melted below the left (east) side of the window. Fire damage occurred along the rock veneer located below the window. The shape of the fire pattern was consistent with a plume-generated columnar pattern. This is due to the fuel package below and the lack of a horizontal ceiling that would produce fire patterns such as a "V" pattern along the lower portion of the wall.

Fire damage occurred below the Bedroom #4 window. A yellow-colored resolidified plastic mass was located along the ground and abutted the north exterior stone veneer wall. It was determined that the resolidified mass was the remains of a plastic shed. Mass loss and consumption of the shed by fire occurred except for the underside, which was in contact with the concrete ground. The center of the mass was located more toward the left (east) side of the Bedroom #4 window. The remains of a metal-framed chair, portable electric heater, and miscellaneous contents were located on top of the resolidified mass.

The north exterior of the structure. Bedroom #4 window is indicated by the blue arrow. The red box indicates the location of the shed prior to the fire. The service conductors from the weatherhead (red arrow) would have been located over the shed location and routed to the northeast utility pole.

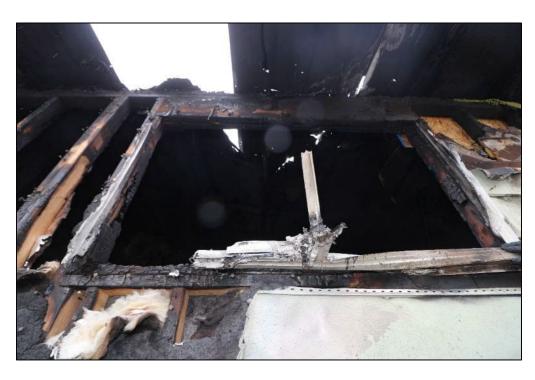
Photograph 10
The remains of the window frame for Bedroom #4 window.

Fire damage occurred to the north interior wall of Bedroom #4. The north interior wall was insulated with fiberglass insulation and provided thermal protection to the wood framing during the fire. This would lessen the fire effects and fire damage to the wood wall framing. Mass loss of the wood framing was most severe at the east side of the north interior wall and occurred at the location of the bunk beds. Mass loss of the window opening was most severe at the east (right) side of the window.

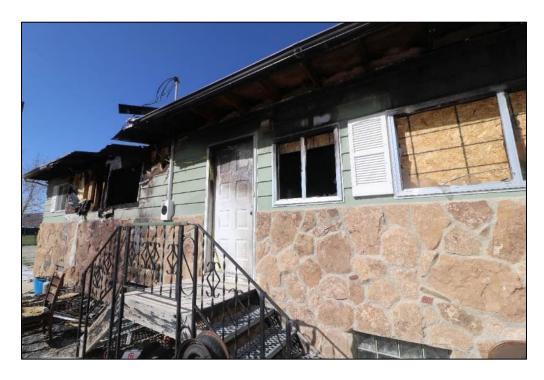
The north exterior of the structure.

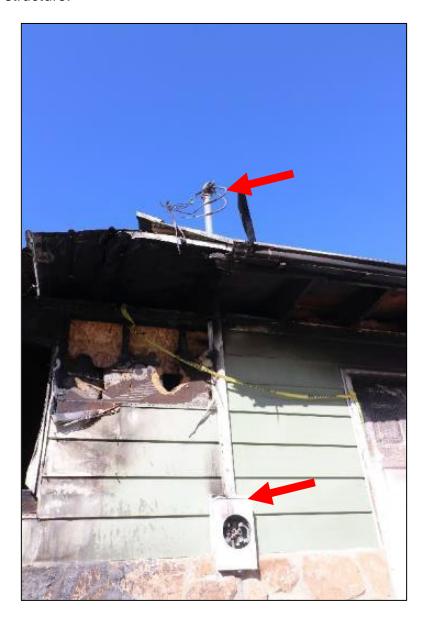
The remains of the weatherhead, service raceway, and meter base located at the north exterior of the structure.

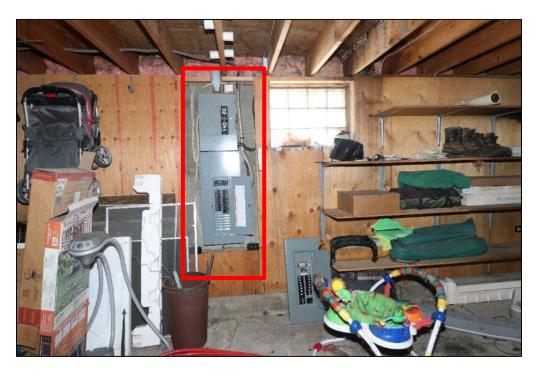
The main disconnect switch was located at the north interior wall of the basement. The main disconnect handle indicated it was in the ON position. No fire damage occurred to the main disconnect switch.

The first circuit-breaker panel was located at the north interior wall of the basement below the disconnect switch. All circuit breakers and the main circuit breaker were in the ON position. There were no tripped circuit breakers. No fire damage occurred to the circuit-breaker panel. Copper conductors in non-metallic sheathed cable provided branch circuit wiring.

The main disconnect switch and first circuit-breaker panel located on the north interior wall of the basement.

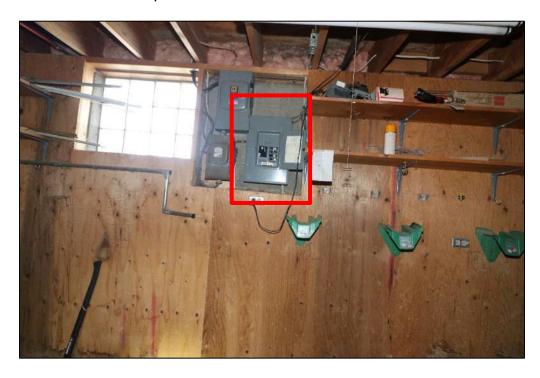
The second circuit-breaker panel.

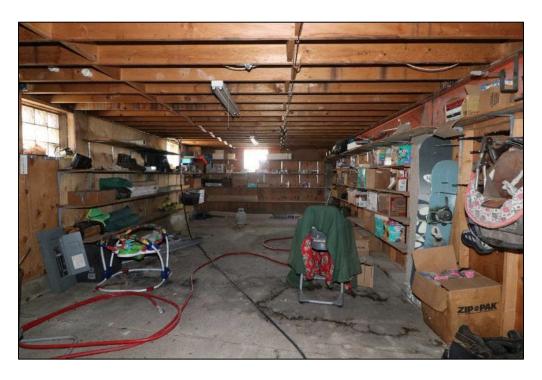
The north interior of the basement.

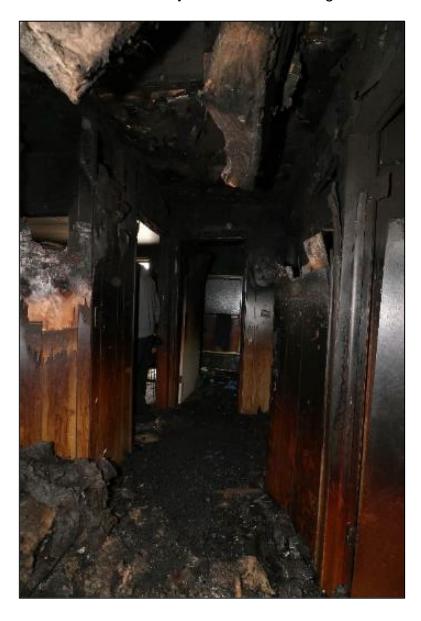
Photograph 31
The east portion of the bedroom hallway as seen while facing east.

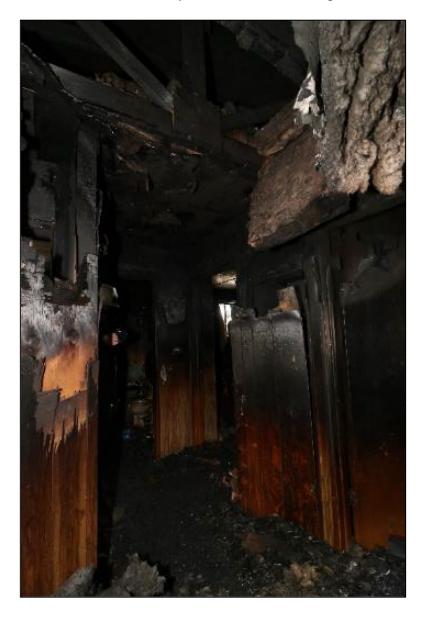
Photograph 32
The east portion of the bedroom hallway as seen while facing northwest.

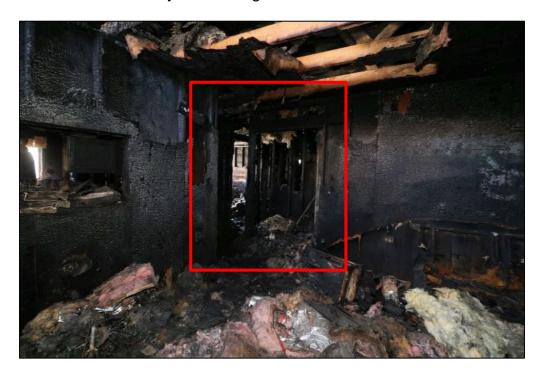
The entrance from the hallway to the living room.

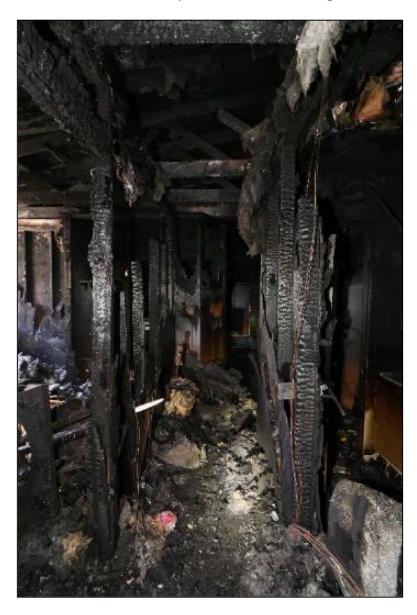
The west portion of the bedroom hallway as seen while facing east.

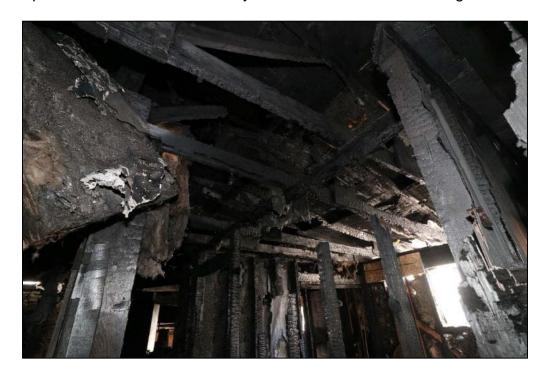
The west portion of the bedroom hallway and attic as seen while facing east.

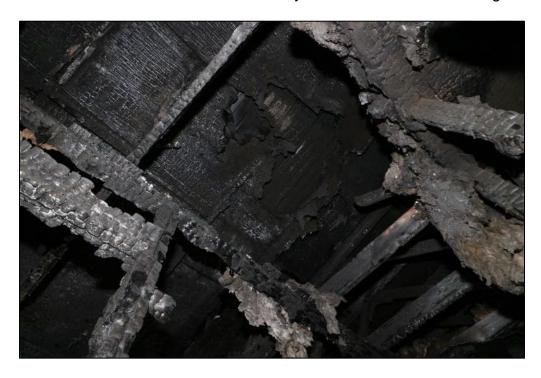
The area of the attic above the bedroom hallway at the location of the ceiling fan.

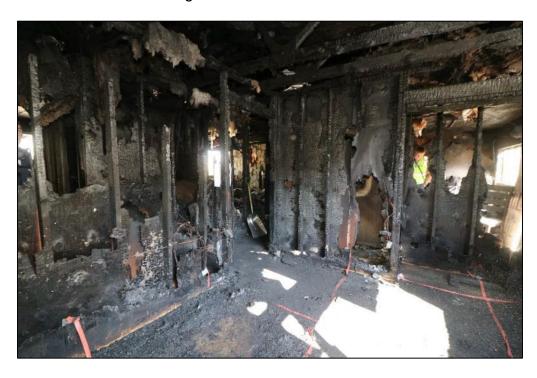
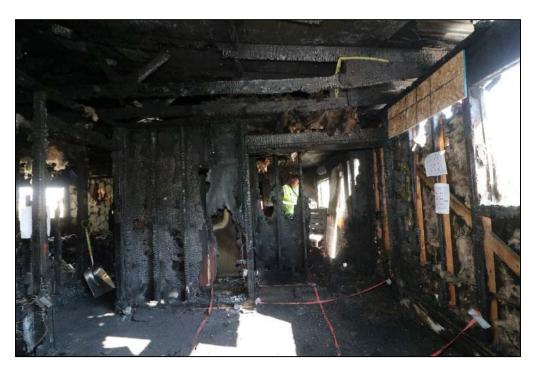
Fire damage occurred in Bedroom #4 and all fire damage increased with proximity to the west side of the bedroom. The fire damage within the bedroom was consistent with full room involvement with fire damage to the floor. This is attributed to the descending smoke and heat layer because of radiant heat flux, convected heat, and the introduction of additional fuel packages within the room during the growth of the fire. Located in the bedroom were bunk beds at the northeast corner, a dresser along the east interior wall, a toy box in the southwest corner, and a hoverboard located along the west interior wall.

The most severe fire damage to the interior of the bedroom was located in the west portion of the bedroom. The increased damage at the west portion of the bedroom continued from the north wall to the south wall. The two vents for this bedroom included the window located along the north exterior wall and the bedroom door located along the south interior wall. The increased damage at the west portion compared to the east portion of the bedroom is consistent with ventilation effects and the flow path that developed between the window and the bedroom door during the growth and spread of the fire within the bedroom. This flow path increased the ventilation effects of the materials at the west side of the bedroom.

Photograph 43
Bedroom #4 as seen while facing southwest.

Photograph 44
Bedroom #4 as seen while facing west.

Photograph 45 Bedroom #4 as seen while facing east.

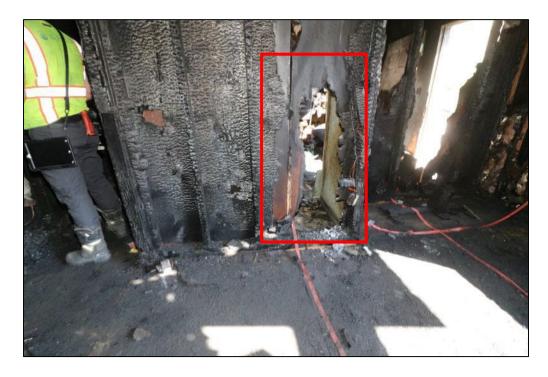
Fire damage occurred to the west interior wall of Bedroom #4. Mass loss of one wood stud occurred in two stud locations from the corner of the west interior wall and the closet. An area of unburned wood paneling was present along the west interior wall that indicated the location of a hoverboard. The lack of fire damage near floor level is consistent with this area being protected by the hoverboard. Located above the location of the hoverboard along the west interior wall was an inverted cone pattern. No V pattern was observed on the west interior wall. The inverted cone pattern was present at the opposite side of the interstitial wall along the west interior wall. The inverted cone pattern is consistent with the fuel package of the hoverboard. The inverted cone pattern is not consistent with a V pattern or an extension of a V pattern.

Photograph 46
The inverted cone pattern on the west wall.

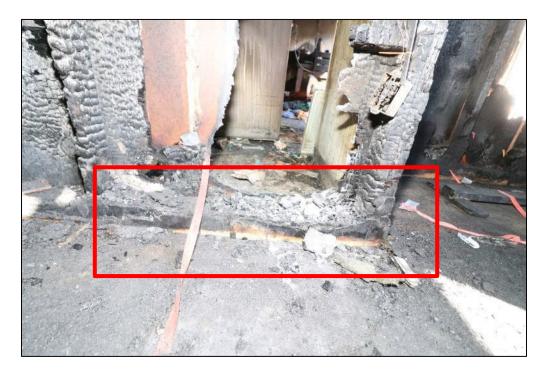
The remains of the hoverboard were discovered along the west interior wall of the bedroom. The location of the hoverboard measured approximately 36 inches from the bedroom door. The door was approximately 36 inches wide. The position of the hoverboard indicated the hoverboard was on the carpet floor in contact with the west interior wall. This is consistent with the unburned wood paneling at floor level. The hoverboard was positioned with one tire to the south and one tire to the north. Fire damage occurred to the hoverboard, and all fire damage increased with distance towards the north side. The south wheel was less consumed by the fire as compared to the north wheel. Fire movement patterns indicated fire progression from the north. The carpet below the hoverboard was intact and consistent with a protected area. The top portion of the hoverboard sustained more severe fire damage as compared to the bottom. Internal wiring and components sustained damage towards the top of the hoverboard with less fire damage towards the bottom. There was undamaged wire insulation within the hoverboard. The lack of internal damage throughout the hoverboard, the protected area of the carpet below the hoverboard, and fire patterns to the hoverboard are not consistent with a fire origin at the hoverboard. There is no indication that the fire originated at the hoverboard along the west interior wall of the bedroom.

The protected area below the inverted cone pattern indicates the location of the hoverboard.

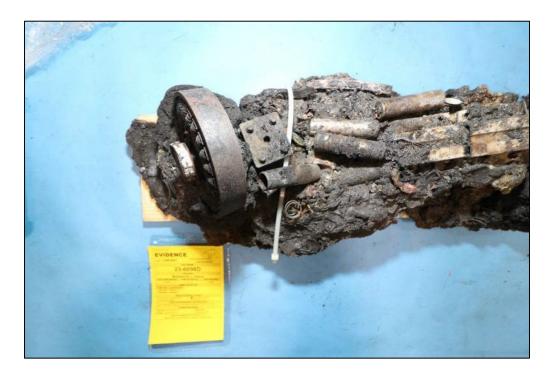
Photograph 51

Internal components of the hoverboard were fire damaged but still had areas of unburned material within the hoverboard.

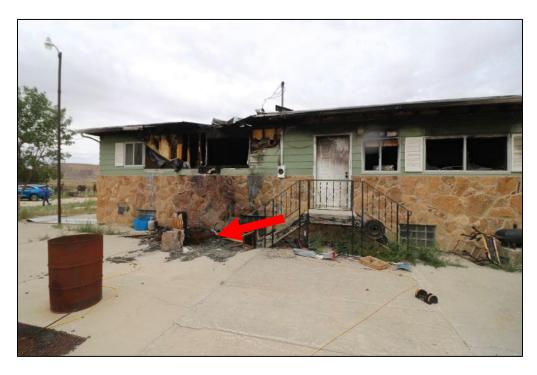
The north exterior of the structure. The remains of the shed were discovered on the concrete ground (red arrow).

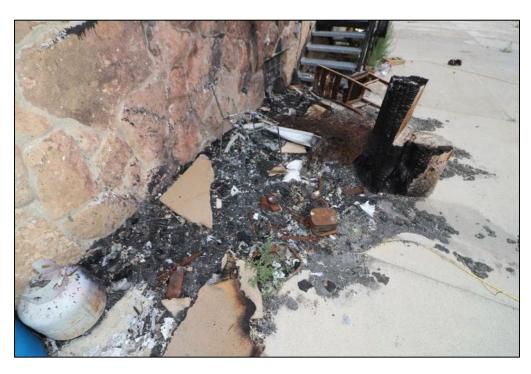
Located within the remains of the shed were the remains of a portable electric heater, an extension cord, a light fixture base, one ashtray, two chairs, an end table with drawers, cigarette packaging, cigarette lighters, and miscellaneous contents. Fire damage occurred to all the interior contents, and the majority of all combustibles except for the bottom of the shed were consumed by the fire.

Photograph 53
The remains of the shed, contents of the shed, and contents around the shed.

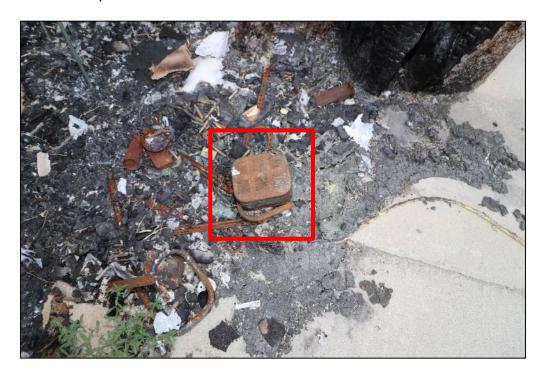
The remains of a portable electric heater were found within the shed. The portable electric heater was located at the northeast corner of the resolidified mass. The portable electric heater was identified as a model CZ250 1500-watt electric shop heater manufactured by Comfort Zone. The portable electric heater was equipped with overheat protection and had three settings, including fan, low and high. Fire damage occurred to the portable electric heater. An extension cord was observed around the remains of the portable electric heater. Evidence of arcing was observed at several locations on the extension cord/power cord for the portable electric heater.

The remains of the portable electric heater.

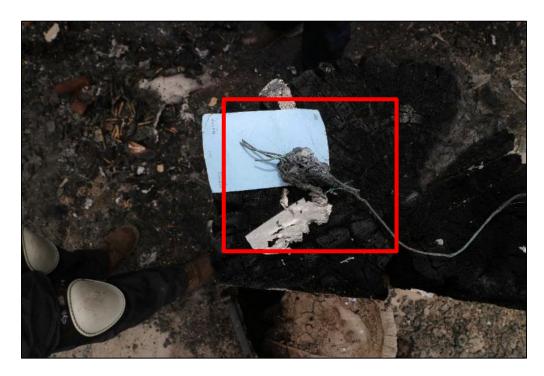
Photograph 55

Evidence of arcing occurred n the extension cord/power cord for the portable electric heater.

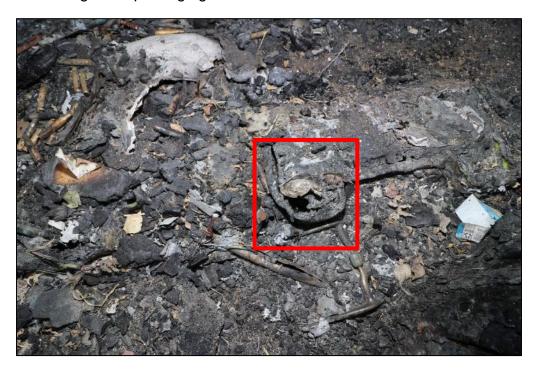
The remains of cigarette packaging foil were observed in the shed contents.

Photograph 57
Remains of cigarette packaging foil.

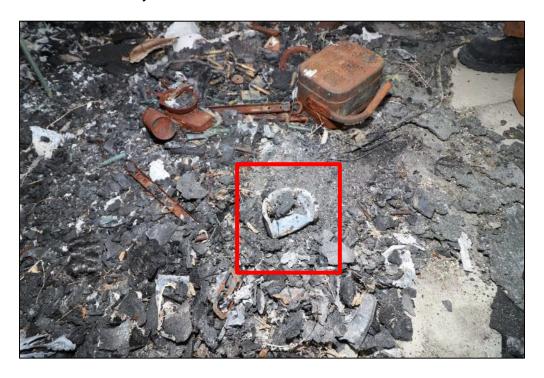
The remains of one ashtray were found in the fire debris. The ashtray measured approximately 3 1/4 inches in height and had a diameter of approximately 4 inches. The burned remains of cigarette butts were observed in the ashtray debris. The remains of the cigarette butt bucket, as described by the Wadsworth family, were not found in the fire debris. If the bucket was made of a combustible material the bucket may have been consumed by the fire.

The remains of the ashtray were observed in the contents of the shed.

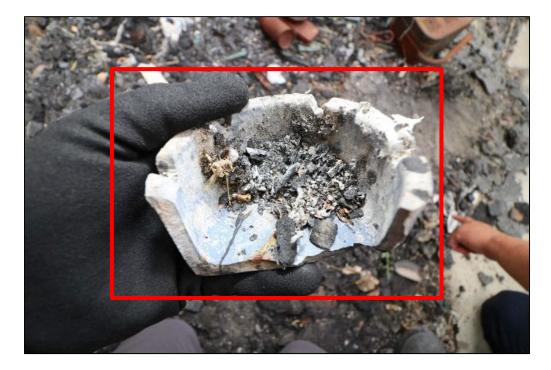
Photograph 59

The remains of the ashtray had remains of cigarette butts.

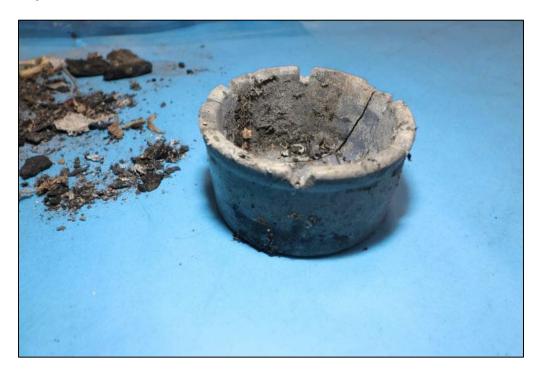
Photograph 61
The remains of lighters and additional cigarette packaging foil.

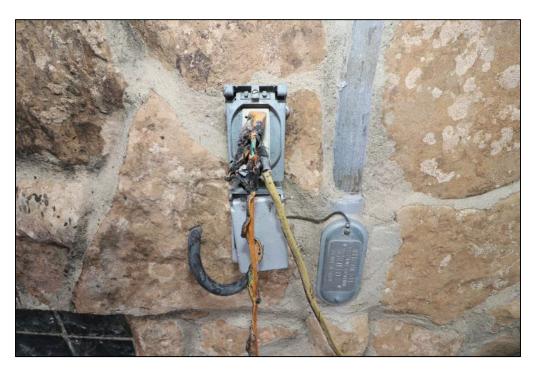
Located along the north exterior wall of the structure, just east of the porch stairs and west of the shed, was an exterior duplex receptacle and a single receptacle. Fire damage occurred on the east side of the duplex receptacle junction box. No fire damage occurred

to the duplex and single receptacle. Two extension cords, one yellow and one orange in color, were plugged into the duplex receptacle. Fire damage occurred to the extension cords near the area of the duplex receptacle. The fire damage was consistent with an external fire attack.

Photograph 63
The north exterior wall receptacle.

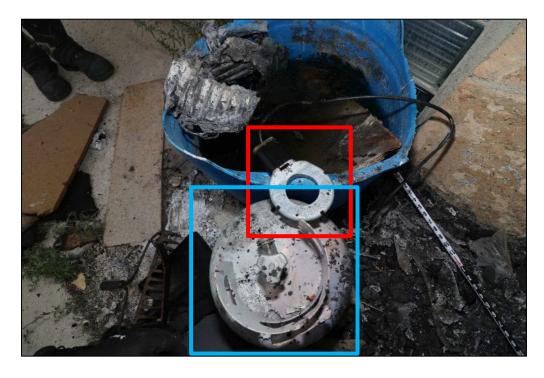
A large blue water bowl was located to the east of the shed. The top portion of the water bowl was melted and resolidified. The lower portions of the water bowl were intact. The damage to the water bowl is consistent with water in the bowl at the time of the fire. A deicer was found submerged in the water bowl. The de-icer was plugged into a yellow extension cord that was routed from a pole near the recreational vehicle parked to the north of the structure. The de-icer is a submersible electric heater that prevents water from freezing. The de-icer was identified as a Model C-50 and was manufactured by Farm Innovators. No fire damage occurred to the de-icer.

A propane tank was located next to the water bowl. The propane tank and valve were intact. Fire damage occurred to the west side of the tank that faced towards the shed. There are no fire patterns around the propane tank consistent with the burning of any escaping gas. There is no indication that propane escaped or was vented from the propane tank during or before the fire.

The remains of the de-icer (red box) and propane tank (blue box).

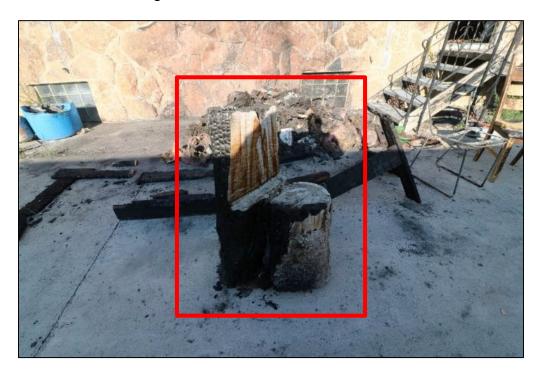
The wood-log chair was located on the north side of the shed. The majority of the fire damage to the wood-log chair was at the south and southeast sides facing the shed.

Photograph 65
The remains of the wood-log chair.
